PIC18F2480/2580/4480/4580 Silicon Errata and Data Sheet Clarification

The PIC18F2480/2580/4480/4580 family devices that you have received conform functionally to the current Device Data Sheet (DS39637D), except for the anomalies described in this document.

PIC18F2480/2580/4480/4580

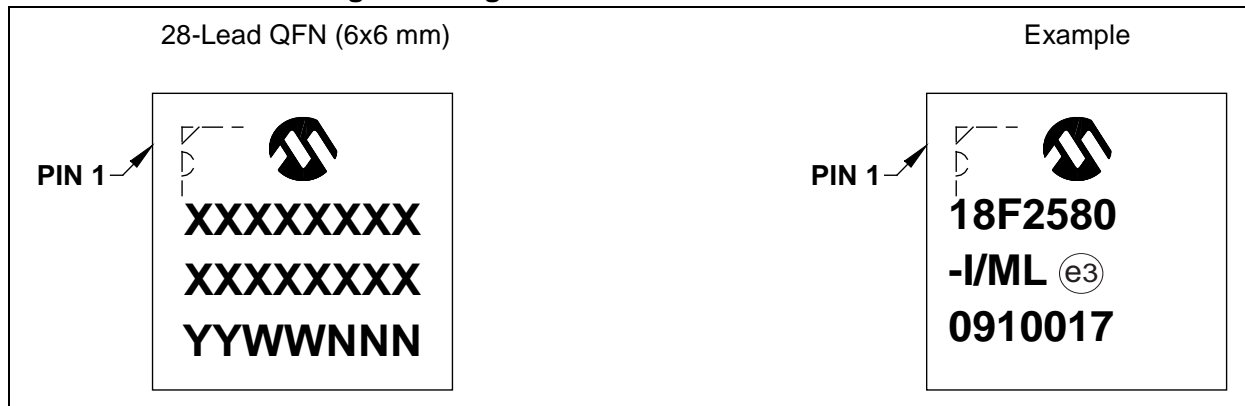
29.1 28-Lead QFN Package Marking Information

The “Pin 1” dot on the 28-Lead QFN package, in the Package Marking Information section, is incorrectly placed. The correct placement is indicated in [Section 29.1 “28-Lead QFN Package Marking Information”](#) below:
