## PIC16C63 Rev. A Silicon Errata Sheet

The PIC16C63 (Rev. A) parts you have received conform functionally to the Device Data Sheet (DS30234D), except for the anomalies described below.

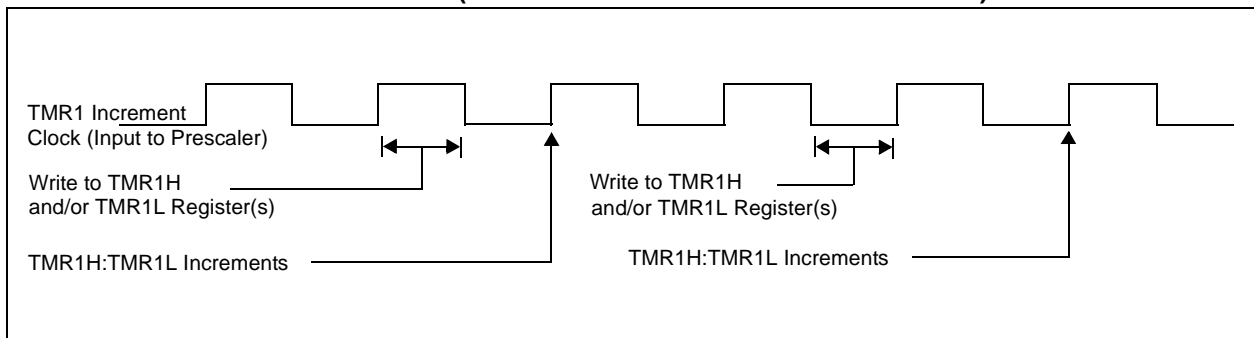
**FIGURE 1: WRITES TO TIMER1 (EXTERNAL CLOCK/OSCILLATOR MODE)**

The internal clock signal that is the input to the TMR1 prescaler affects the incrementing of Timer1 (TMR1H:TMR1L registers and the Timer1 prescaler). When the Timer1 registers are NOT written, the Timer1 will increment on the rising edge of the TMR1 increment clock.

When the TMR1H and/or TMR1L registers are written while this clock is high, TMR1 will increment on the next rising edge of this clock.

When the TMR1H and/or TMR1L registers are written while this clock is low, TMR1 will not increment on the next rising edge of this clock, but must first have a falling clock and the rising clock for TMR1 to increment.

Figure 1 shows the two cases of writes to the TMR1H and/or TMR1L registers. Due to the  $V_{IH}$  and  $V_{IL}$  thresholds on the oscillator/clock pins, external Timer1 oscillator components, and external clock frequency, the Timer1 increment clock may not be of a 50% duty cycle.

The TMR1 increment clock is out of phase of the T1OSO/T1CKI pin by a small propagation delay.
